Dam Metallized in Freezing Conditions To Beat Schedule

by Lori R. Huffman, Associate Editor

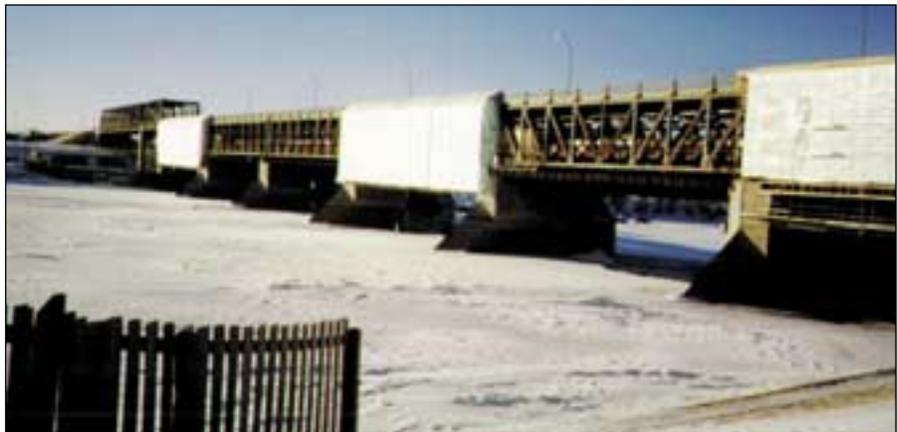
Fig. 2 - Containment structures for blasting, metallizing, and climate control throughout job. Photo courtesy of PWGSC and Wardrop Engineering

The contractor used three containments during the operation: one for abrasive blasting; another for metallizing; and a third for the next area to be worked on. To allow workers a fast transition from one area to the next, the third containment was set

up while the other two were in use, says Turcotte (Fig. 2).

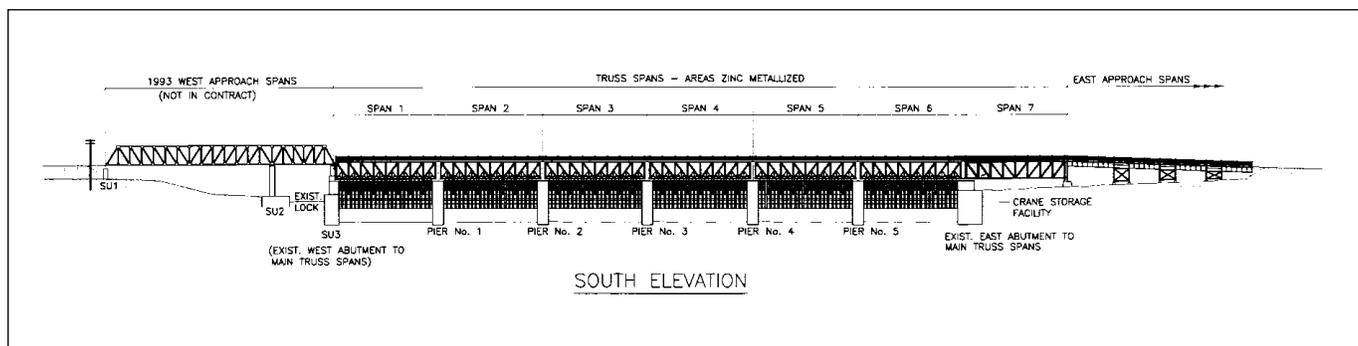
Fig. 1 - Schematic shows metallizing project on St. Andrews Lock and Dam in relation to whole structure. Courtesy of PWGSC and Wardrop Engineering

tice box beams riveted together. Channels, I-beams, and latticed built-up sections were employed to make up the other components of the structure. Below the working floor are the moveable, tapered/built-up, dam frame girders. These are supported by an elaborate system consisting of steel hangars, thrust wedges, and steel castings. The seventh span is made up of two main trusses identical to those supporting the road deck in Spans 1-6. It also includes a crane storage facility."¹ Figure 1 is a schematic of the lock and dam.
